MEMORANDUM

DATE: June 10, 1999

SUBJECT: LPC #0218100005 - Christian County
Pana/South Central Terminal
ILD #084309210
FOS

LPC 021810 0005 - Christian County
Pana/South Central Terminal

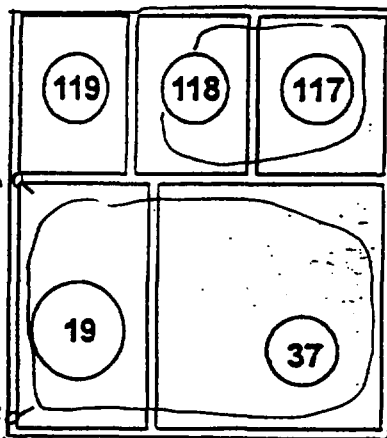
TRAIL OF STAINED & DEAD
VEGETATION

MOIST
(NO
FLOW)

TRAIL OF Ammonium SULFATE
MATERIAL & STORM WATER
